## **Machine Runs On Its Own!**

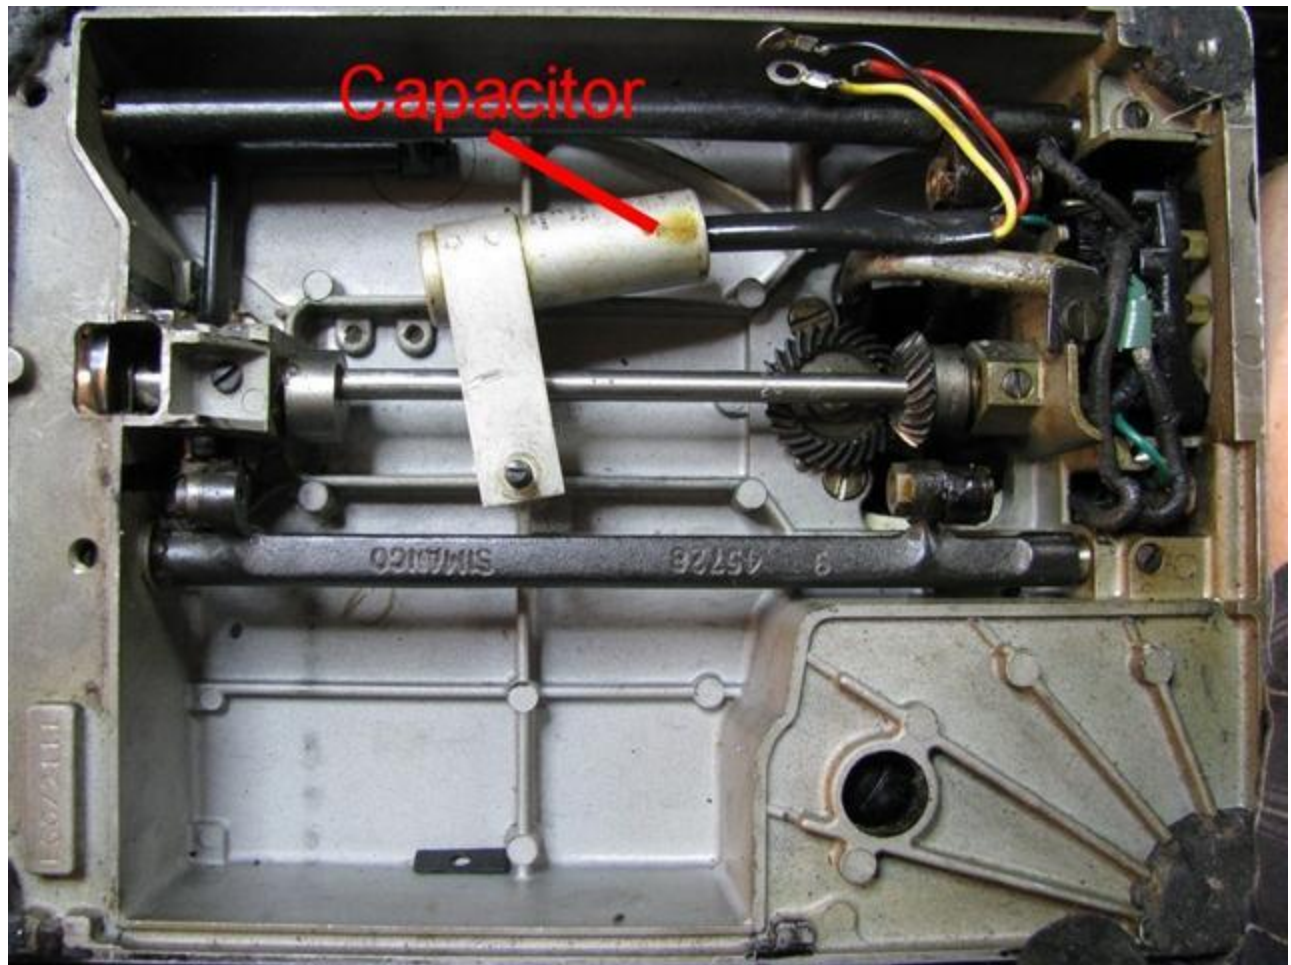
There are two locations that Singer used for these noise suppression devices, either under the machine oil pan, or in the foot control. I have heard that they may be in both locations on the same machine, but I have not yet seen this. Regardless, the photo below shows the under-machine location, and this device was wired to the 3-pin connector (already disconnected). To remove you can either cut the wires at the back of the 3-pin connector, making sure that the remaining wire does not come in contact with the other wires or the machine body, or better yet, simply remove the screw holding the 3-pin connector and disconnect the wires from the 3-pin connector. Throw the capacitor away.

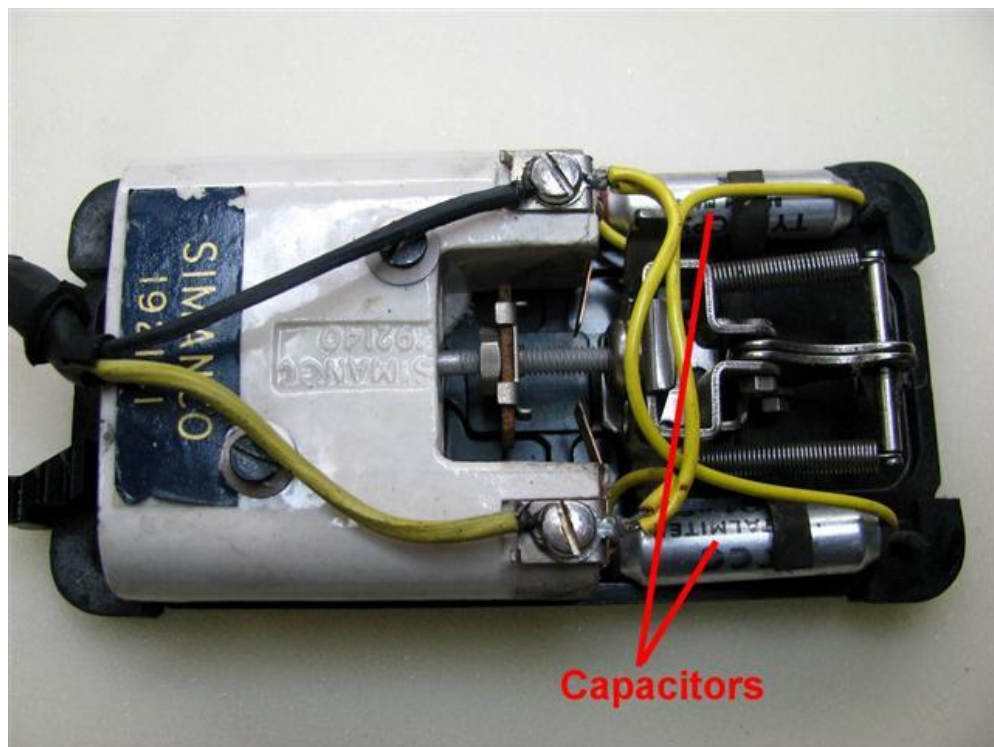
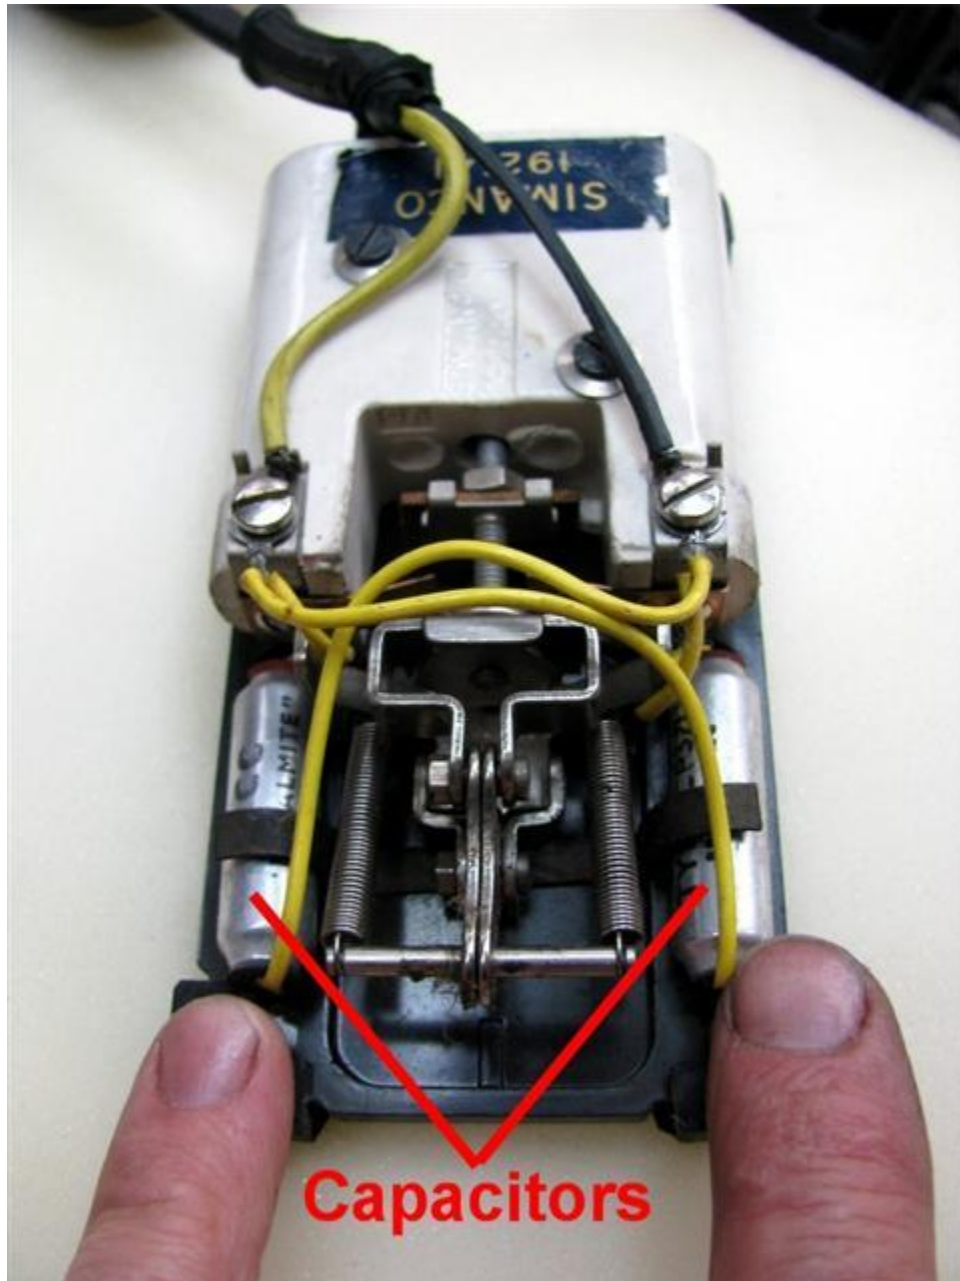
In the photos below you will see the foot control with the cover removed revealing 2 capacitors.

You can easily remove these devices without any issue. Simply remove the screws at each terminal and remove the wires that are attached to the capacitor, then reattach the main foot control wires. Pull the capacitors out of their brackets and discard.

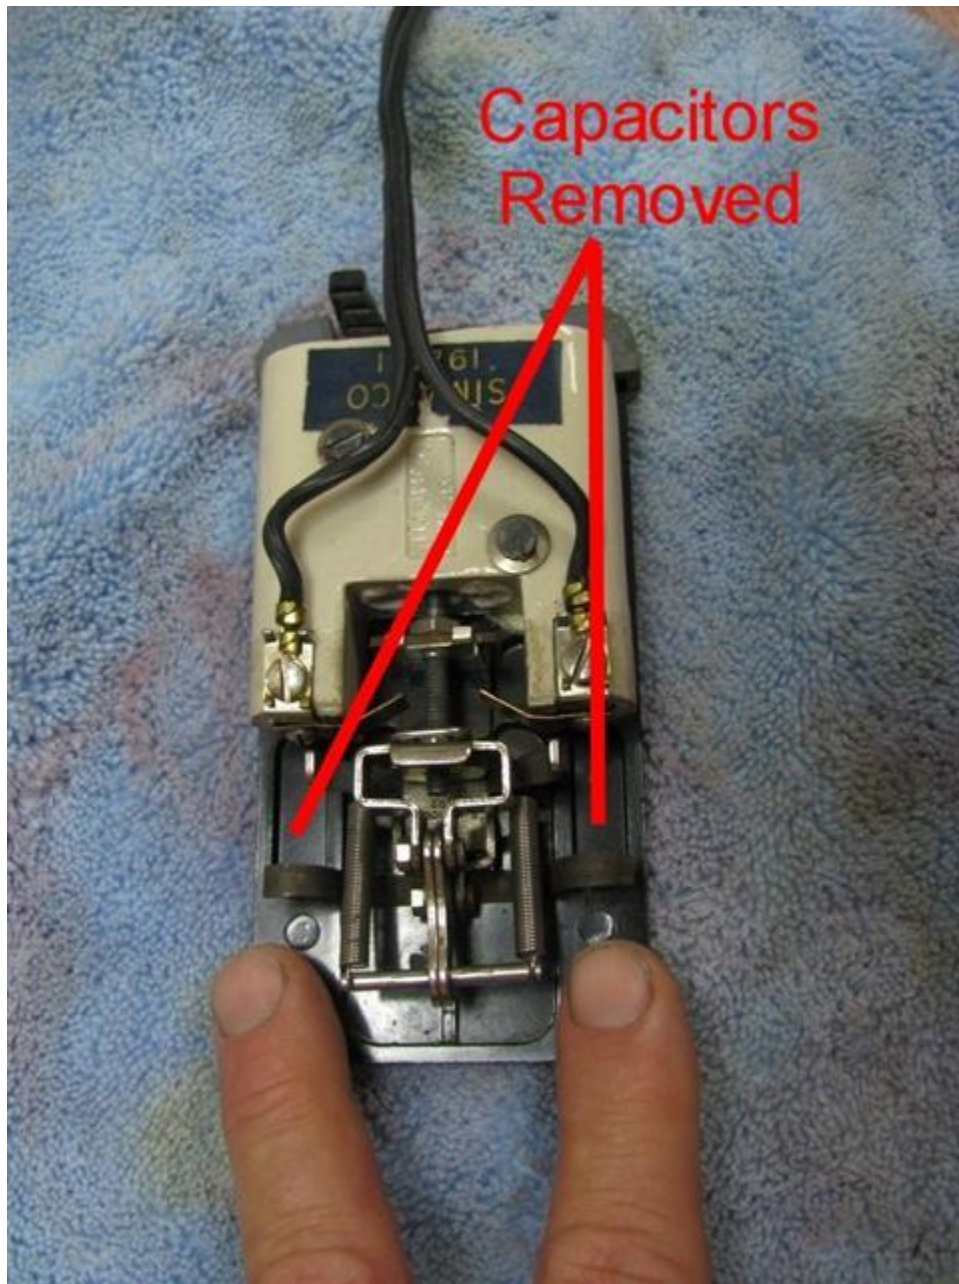
The photo below shows the capacitors removed from the foot control.

Your machine should now have the electrical sneak path removed and you should again have full control of your Featherweight!

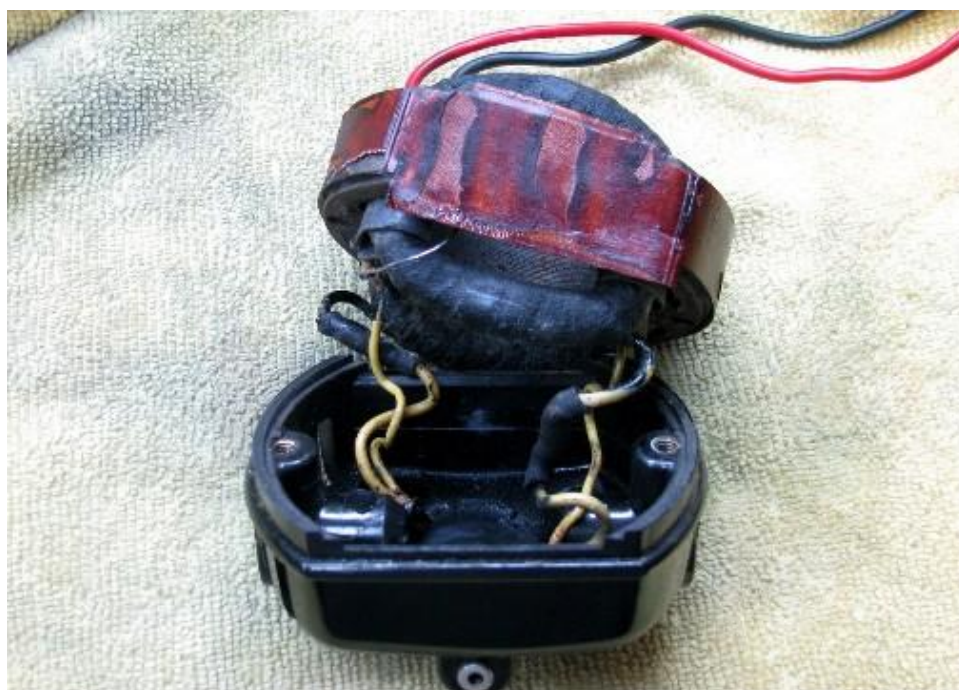
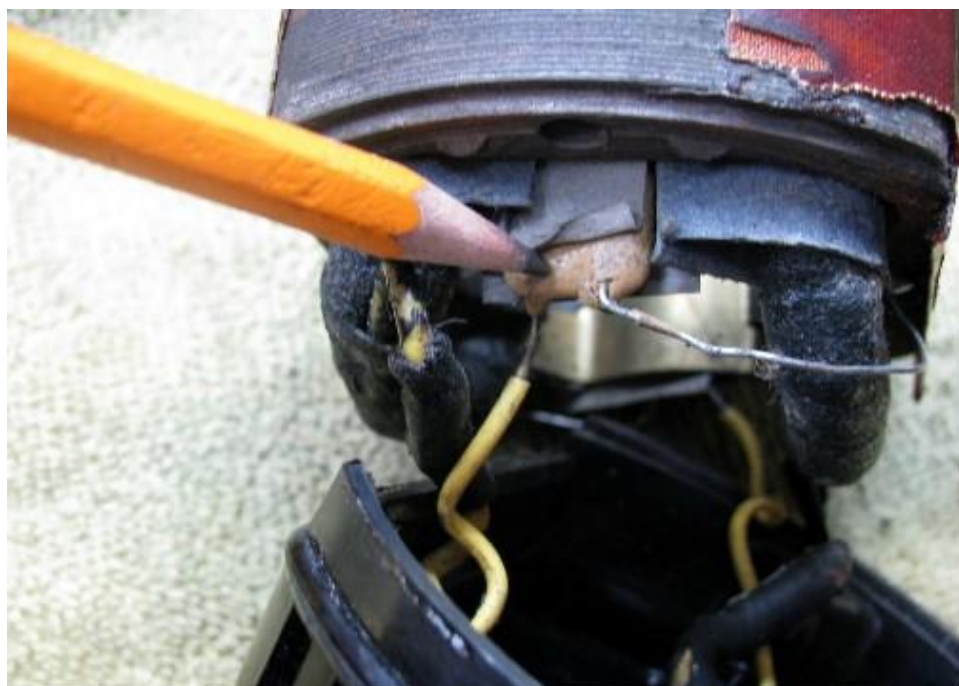
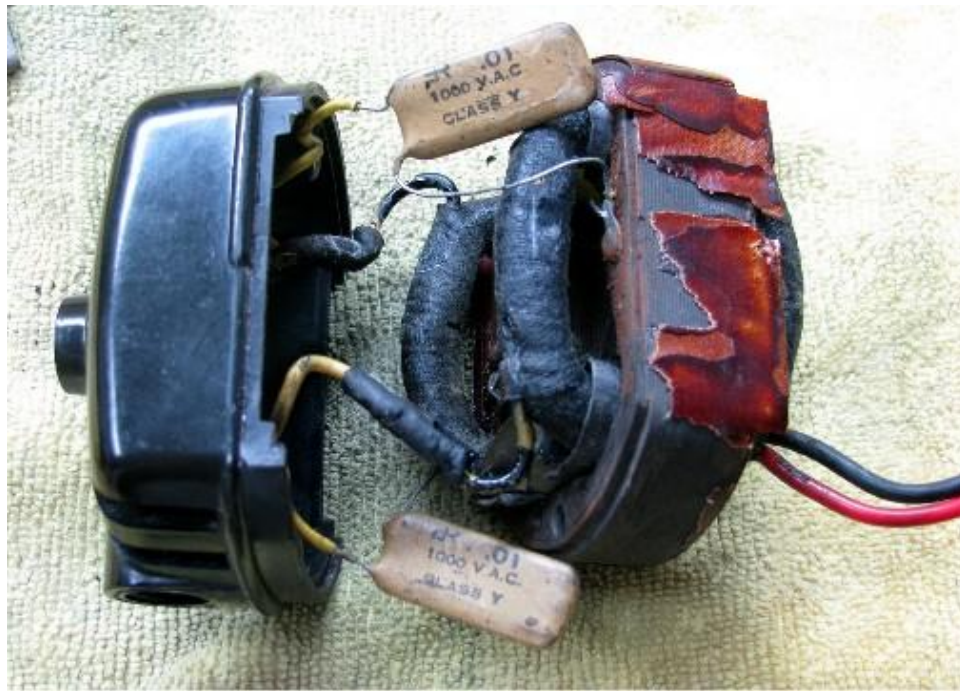
Recently, while servicing a Featherweight motor I noticed "extra" wires coming off the motor brush tubes. Upon closer examination, I discovered that the motor had noise suppression capacitors installed within the motor itself! This was my first time finding this on a Featherweight, so I thought I would add photos on this discussion.

I would not recommend removal of these capacitors by a novice. Better to take the motor to a qualified electrician for removal.
